NASA Technical Paper 1042

Light Airplane Crash Tests
at Impact Velocities
of 13 and 27 m/sec

Emilio Alfaro-Bou and Victor L. Vaughan, Jr.

NOVEMBER 1977

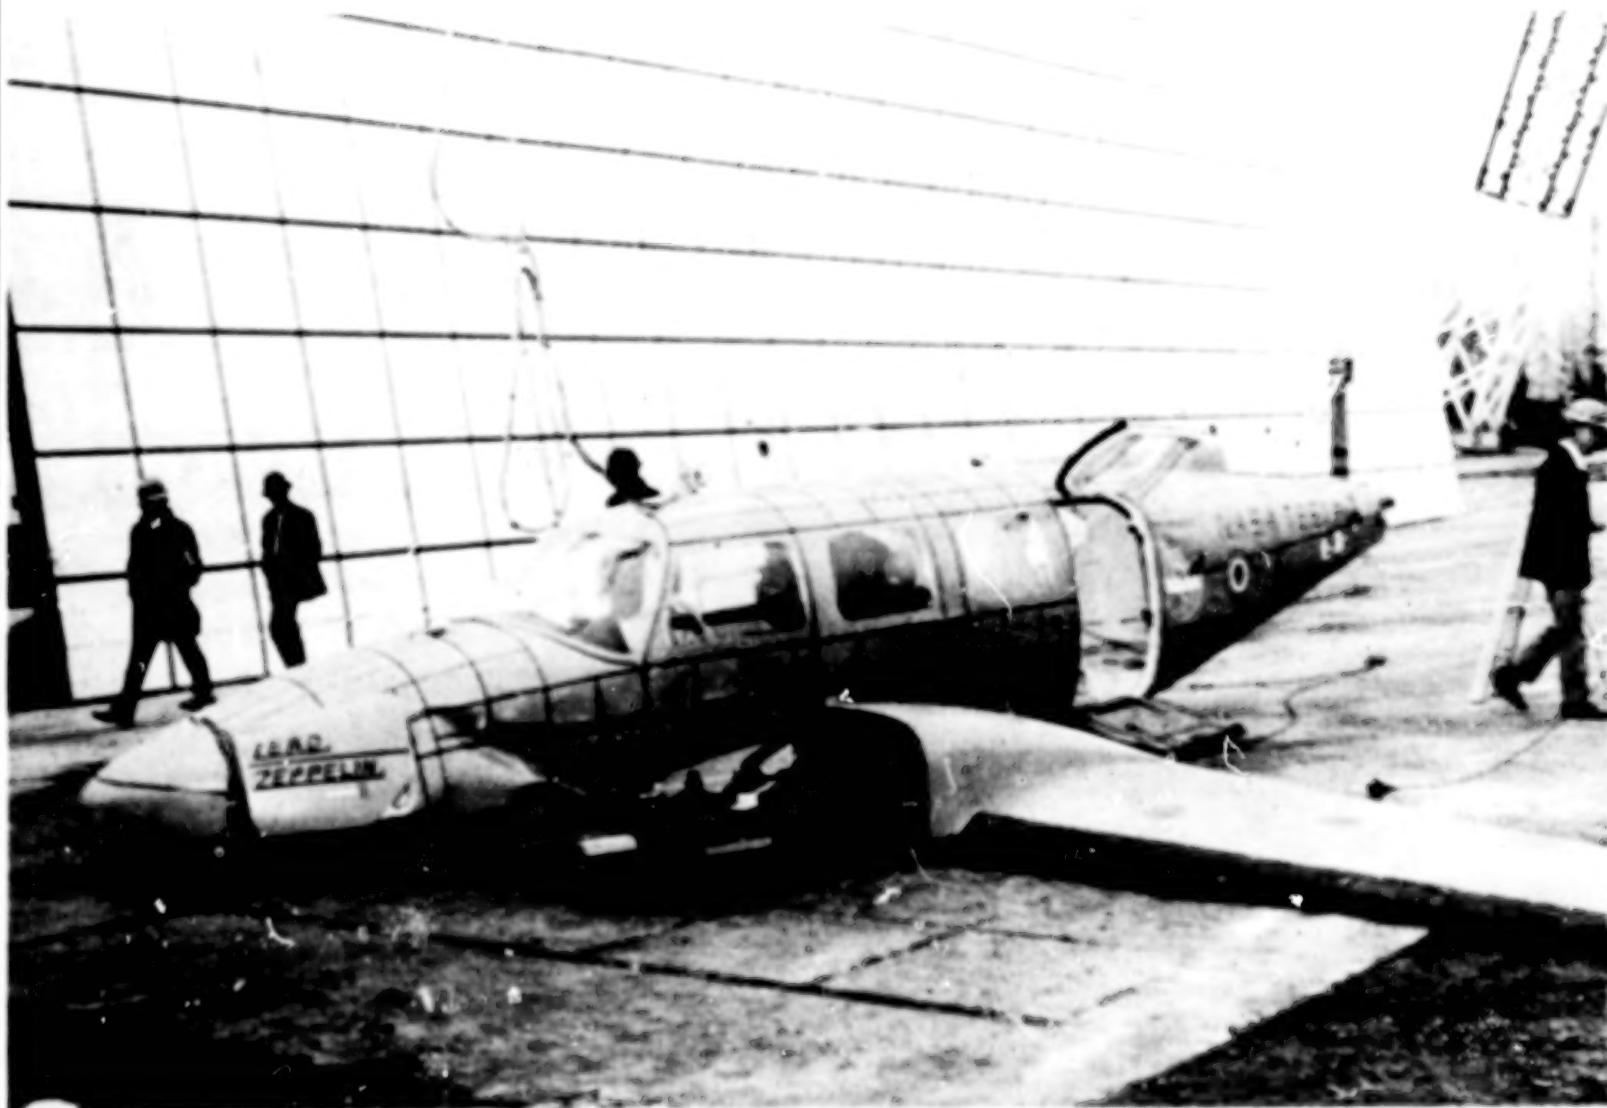
Photographs showing external damage to the specimens for tests 1 and 2 are shown in figures 10 and 11, respectively. The damage to the nose area of the specimen was approximately the same for both tests. (See figs. 10(a) and 11(a).) The crash forces in the nose area were more intense and the damage more severe than in other parts of the specimen. However, the damage was restricted to the cowling and fire wall where most of the impact energy was absorbed by crushing of the structure during nose contact. Some of the remaining energy in the form of small attenuated forces and motions was transmitted to the cabin area.

(a) Overall damage.

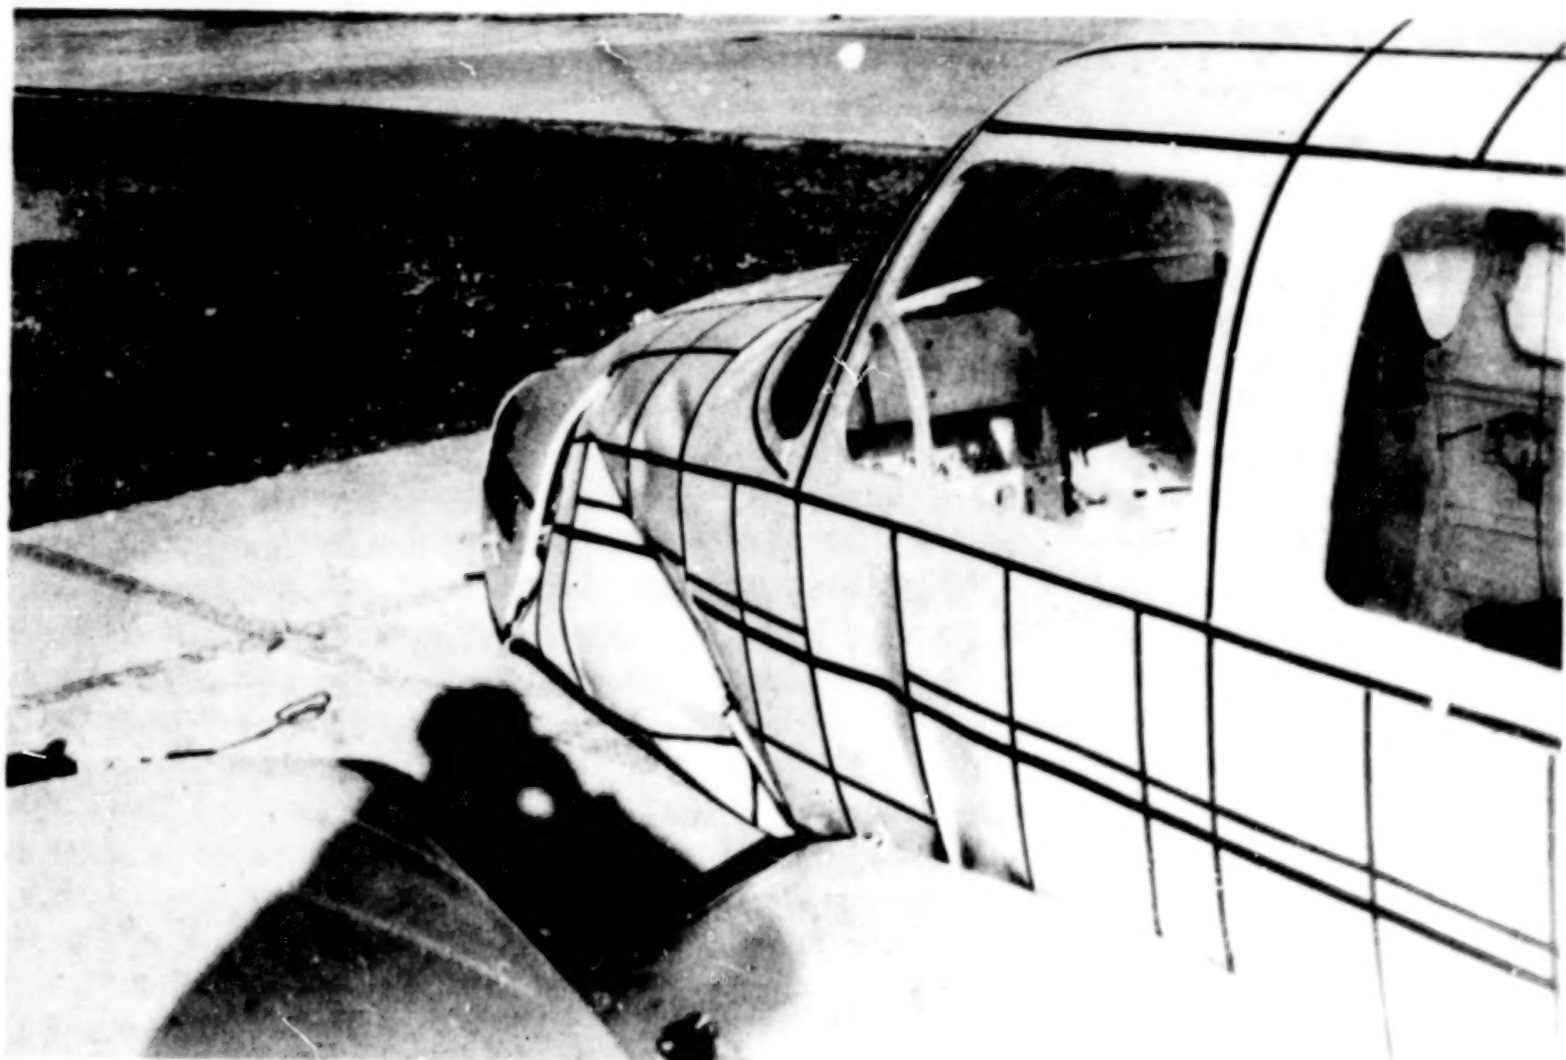
(b) Closeup of nose damage.

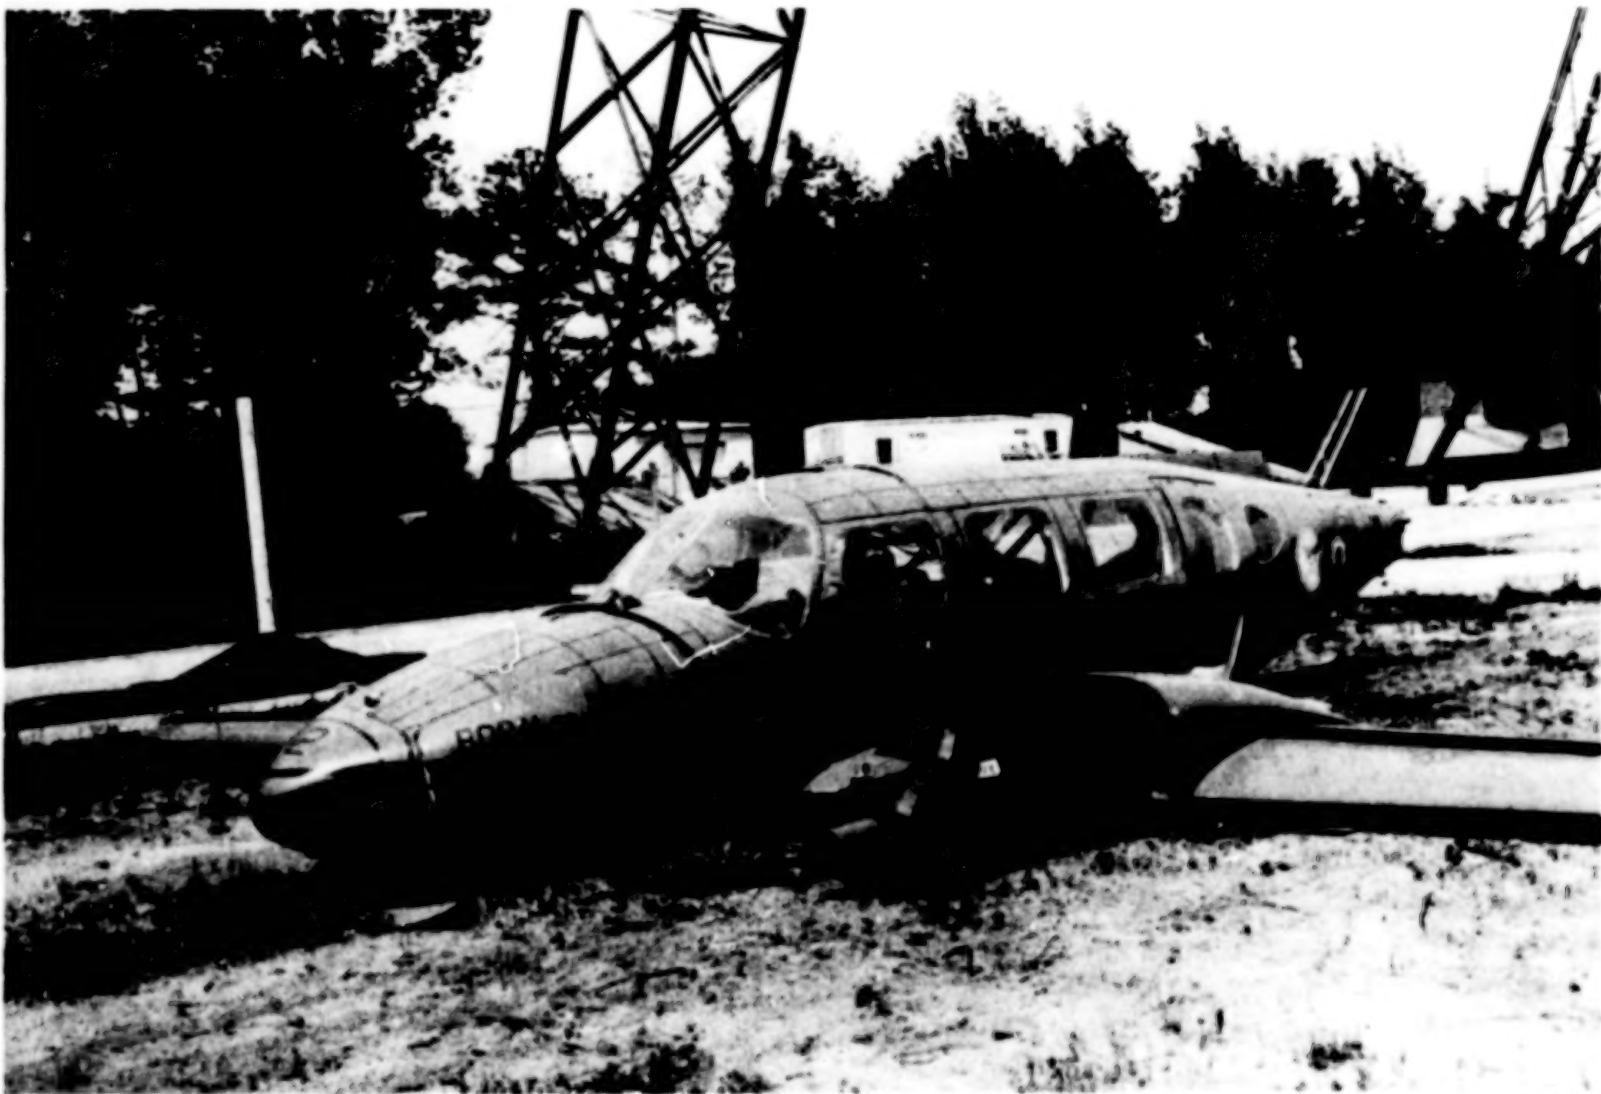
In test 2 the skin wrinkled from nose to tail on both sides of the fuselage. The overlapping sheet metal on top of the fuselage separated along the rivet line behind the first window due to rivet shear. Similar breaks occurred along the rivet line at the base of the windows. (See figs. 11(a) and 11(b).) The separation along the rivet line on top and along the side of the fuselage occurred during second impact when the roof continued to move downward as the floor was brought to rest and this movement caused a lateral expansion of the cabin.

(a) Overall exterior damage.

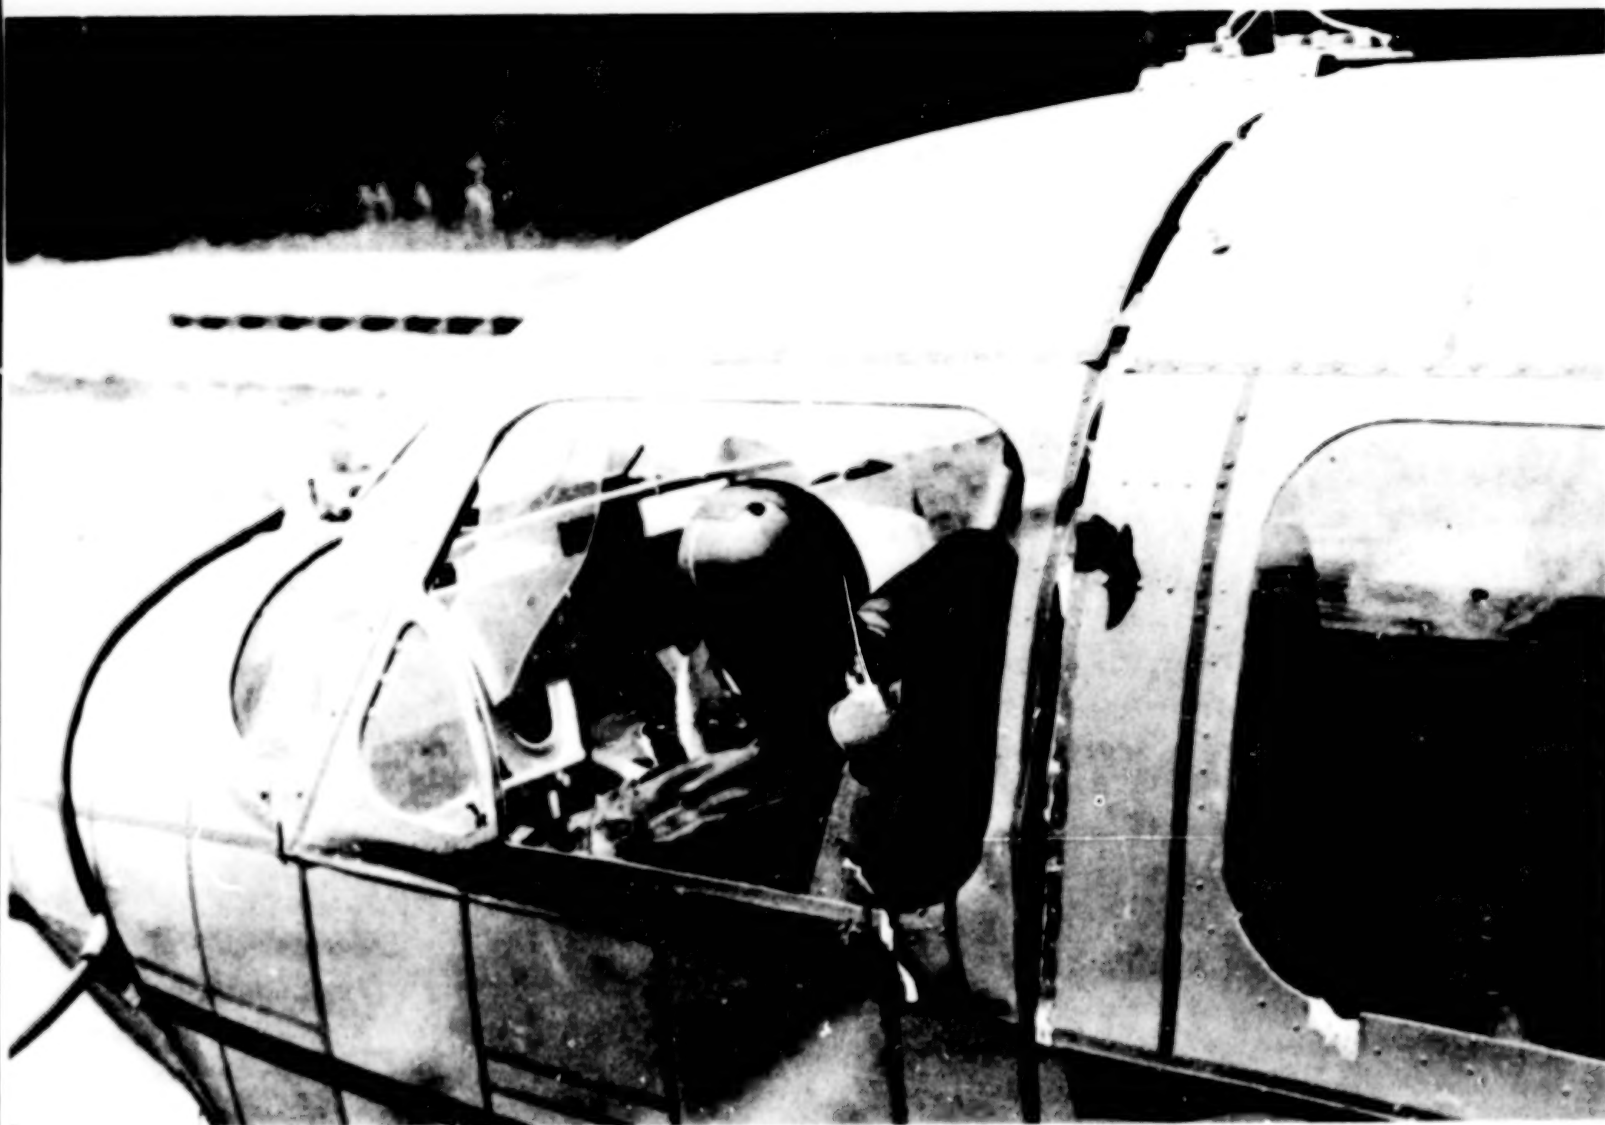
(b) Sheet metal separation along rivet lines.

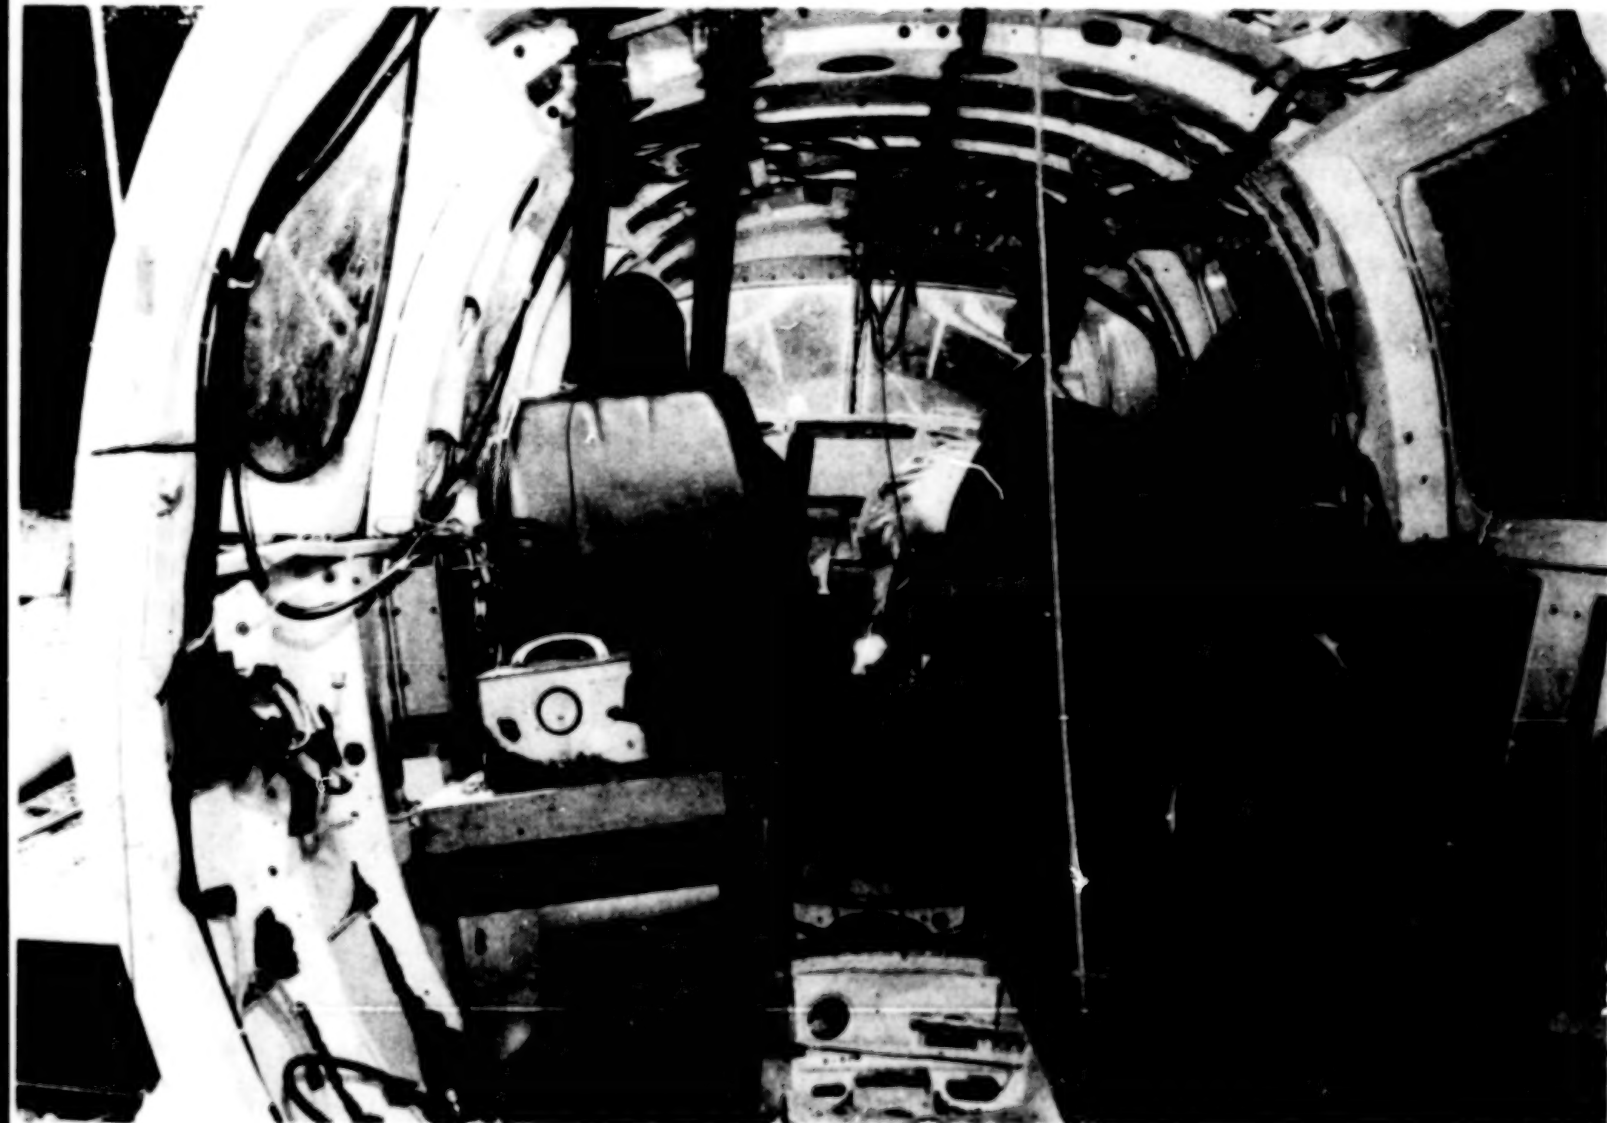
The interior damage to the cabin in test 1 was relatively mild, significant damage occurring in the fore cabin in the vicinity of the instrument panel and fire wall. The damage to the cabin interior for test 2 is shown in figures 11(c) and 11(d). In test 2 the cross members in the floor structure under the front legs of the pilot and copilot seats collapsed. This was due to the forward and downward thrust of the seats and occupants. In the cabin area aft of the main spar (fig. 11(c)), the structural damage is evident in the deflection of the two outer floor panels about the floor beams. During second impact, the rounded

bottom portion of the fuselage beneath the floor beams contacts the ground and is flattened. As the impact progresses, the vertical motion of the floor beams is arrested while the roof and sides of the cabin continue to move downward. This downward movement of the sidewalls causes the two floor beams to appear to move upward and outward. This deformation pattern continues until the impact energy is dissipated in deforming the cabin structure. At maximum cabin deformation the support frames yielded on their sides and the cabin assumed an oval shape (fig. 11(d)). In test 2, at maximum cabin deformation the sides of the airplane moved outward 21 cm at the center and the distance between the roof and the floor was reduced by 23 cm. Figure 12 presents peak-to-peak normal and longitudinal accelerations at longitudinal stations along the specimen structure. Peak-to-peak accelerations measured normal to the floor beam for tests 1 and 2 are shown in figure 12(a). They give a general idea of the acceleration levels at various locations adjacent to the floor beams. The average peak-to-peak acceleration was 78 percent higher in test 2 than in test 1. For both tests, the accelerations were higher at the nose and near the main spar, and lower at the fire wall and toward the rear of the cabin.

(c) Interior damage.
